**Flood Control Project Maintenance
Levee Inspections**

Maintenance Issue Types Only, Levee Inspection Report By Mile - Spring 2018

Reclamation District No. 2107 Mossdale Island

Waterway	Bank	Unit Miles	Inspection Start/End	Inspector
Unit No. 01 San Joaquin River	Left	2.33	03/07/2018 03/07/2018	Maksim Khashchuk

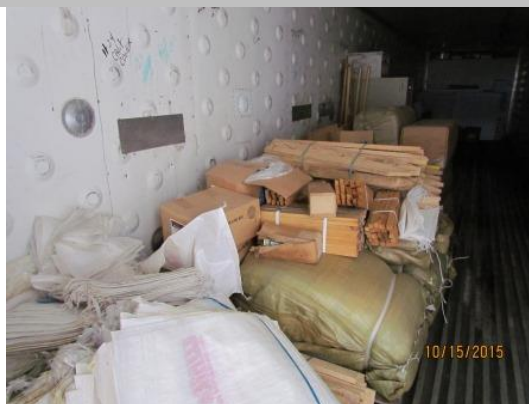
Photo 1 of 1 : SP_2018_RD2107_329_7_20180305_00001.jpg

LM Start		Rating **	A	Issue No.	7
LM End		Issue Type +	Ma	Location *	
Category	Earthen Levee		GPS Latitude/Longitude		
			Start	End	
Item	Emergency Supplies & Equipment				
DWR ID	DWR_RD2107_01_s_2013_7				
Comment Code					
Inspector Comment					
Flood fighting supplies are available on-site.

View of the flood fight emergency supplies.

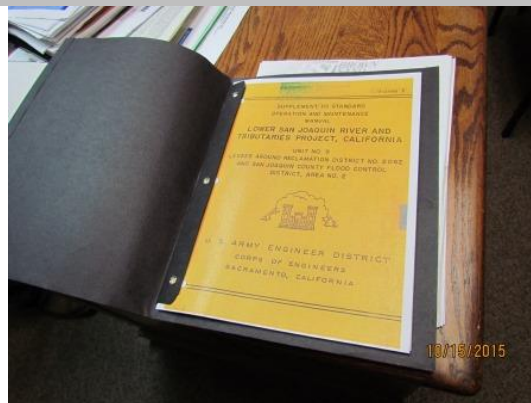
Photo 1 of 1 : SP_2018_RD2107_329_8_20180305_00002.jpg

LM Start		Rating **	A	Issue No.	8		
LM End		Issue Type +	Ma	Location *			
Category	Earthen Levee			GPS Latitude/Longitude			
				Start		End	
Item	Operations & Maintenance Manuals				o		o
					o		o
DWR ID	DWR_RD2107_01_s_2013_8						
Comment Code							
Inspector Comment							
The O&M Manual is available at the LMA's office.

View of the O&M Manual.

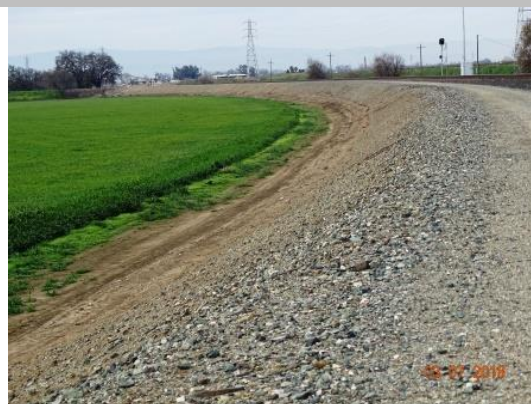
Photo 1 of 1 : SP_2018_RD2107_329_14_20180307_00024.jpg

LM Start	0.78	Rating **	A	Issue No.	14
LM End	0.78	Issue Type +	Ma	Location *	WS
Category	Earthen Levee			GPS Latitude/Longitude	
				Start	End
Item	Vegetation			37.778668 °	37.778668 °
				-121.303248 °	-121.303248 °
DWR ID	DWR_RD2107_01_s_2018_14				
Comment Code					
V1 : Control annual grass and weeds on the levee slopes and easements.					
Inspector Comment					
Acceptable vegetation control.

View of the acceptable vegetation control on the waterside levee slope, looking upstream.

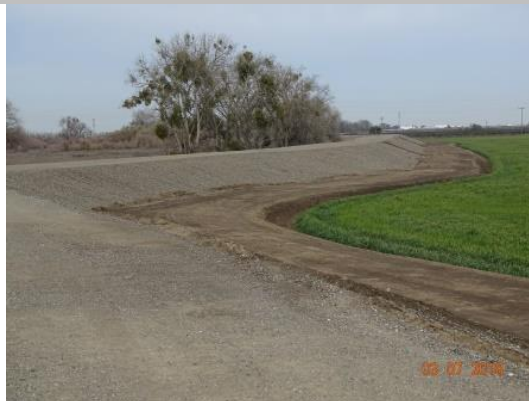
Photo 1 of 1 : SP_2018_RD2107_330_5_20180307_00010.jpg

LM Start	0.17	Rating **	A	Issue No.	5
LM End	0.17	Issue Type +	Ma	Location *	LS
Category	Earthen Levee			GPS Latitude/Longitude	
				Start	End
Item	Vegetation			37.761664 °	37.761664 °
				-121.312122 °	-121.312122 °
DWR ID	DWR_RD2107_02_s_2018_5				
Comment Code					
V1 : Control annual grass and weeds on the levee slopes and easements.					
Inspector Comment					
Acceptable vegetation control.

View of the acceptable vegetation control on the levee slope, looking downstream.

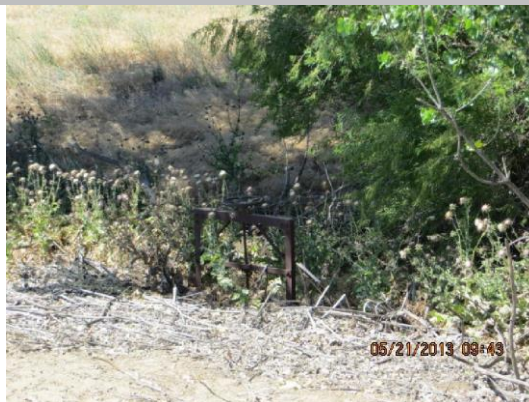
Photo 1 of 2 : UCIP_SP_2018_13637_22299.jpg

LM Start	0.27	Rating **	M	Issue No.	6	
LM End	0.27	Issue Type +	Ma	Location *		
Category	Supplemental			GPS Latitude/Longitude		
				Start	End	
Item	DWR UCIP LMA Responsibility			37.762613 °	37.762613 °	
				-121.313480 °	-121.313480 °	
DWR ID						
Comment Code						
Inspector Comment						
FS_ID:13637						
DS_ID:19057						
EP_NO: N/A						
Repair Type: Non-Urgent						
Crossing Status: Found						
UCIP Comments: Pipe filled in with soil around outlet and not visible on						
LS. Appears abandoned and should be done so properly.						
FIELD_STRUCT_DESC: *ABANDONED* 16-inch steel drainage pipe,						
16 feet below the crown. Slide gate on the waterside (WS) toe.						
[Additional Reference(s): DWR Levee Log, 2005. USACE San Joaquin						
O&M Manual 9, April 1964, (HLM 0.27)].						
FS Date: 5/21/2013

Slide gate visible on WS toe.

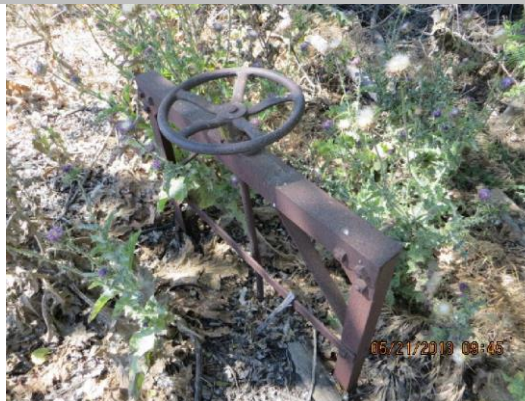
Photo 2 of 2 : UCIP_SP_2018_13637_22298.jpg

LM Start	0.27	Rating **	M	Issue No.	6 (cont)	
LM End	0.27	Issue Type +	Ma	Location *		
Category	Supplemental			GPS Latitude/Longitude		
				Start	End	
Item	DWR UCIP LMA Responsibility			37.762613 °	37.762613 °	
				-121.313480 °	-121.313480 °	
DWR ID						
Comment Code						
Inspector Comment						
FS_ID:13637						
DS_ID:19057						
EP_NO: N/A						
Repair Type: Non-Urgent						
Crossing Status: Found						
UCIP Comments: Pipe filled in with soil around outlet and not visible on LS. Appears abandoned and should be done so properly.						
FIELD_STRUCT_DESC: *ABANDONED* 16-inch steel drainage pipe, 16 feet below the crown. Slide gate on the waterside (WS) toe.						
[Additional Reference(s): DWR Levee Log, 2005. USACE San Joaquin O&M Manual 9, April 1964, (HLM 0.27)].						
FS Date: 5/21/2013

Slide gate visible on WS toe.
